TSURUMI PUMP

Application Reports in 2008

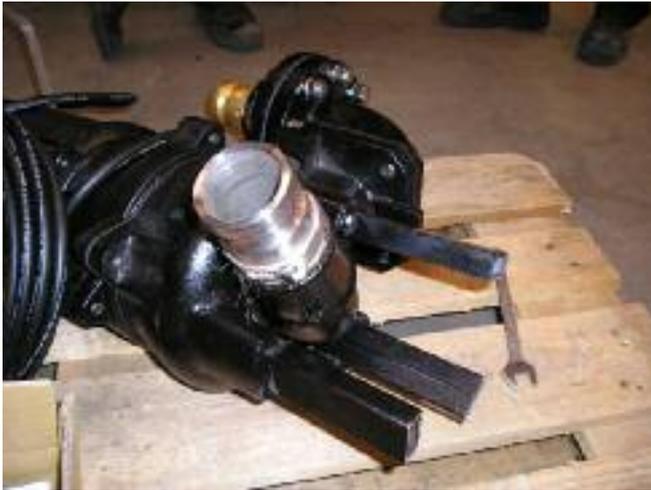
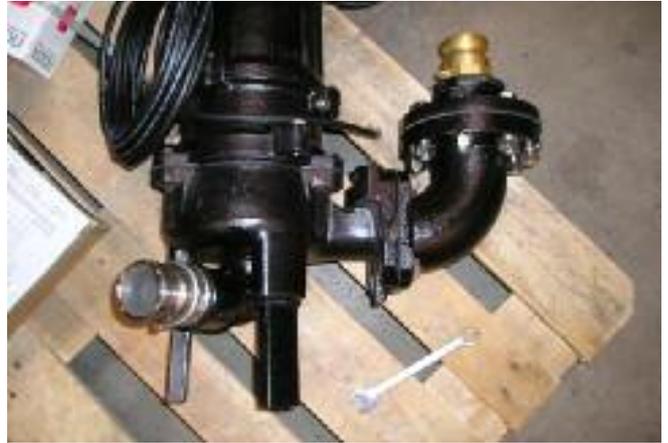
Energiewerke Nord, Lubmin, Germany

Pumping of residue from thermal groundwater treatment through a filter

Cleaning of a decomposition basin as a custom solution.

A model 80U23.7 drainage pump was rebuilt to permit the suction line to be mounted directly on the pump intake.

This allowed a flexible suction nozzle to be connected on the suction side, and a complete filter on the pressurized side for the retention of solids (slag, shavings, small parts). Used entirely underwater for flexible positioning, since there was no container sump and a flat container floor.

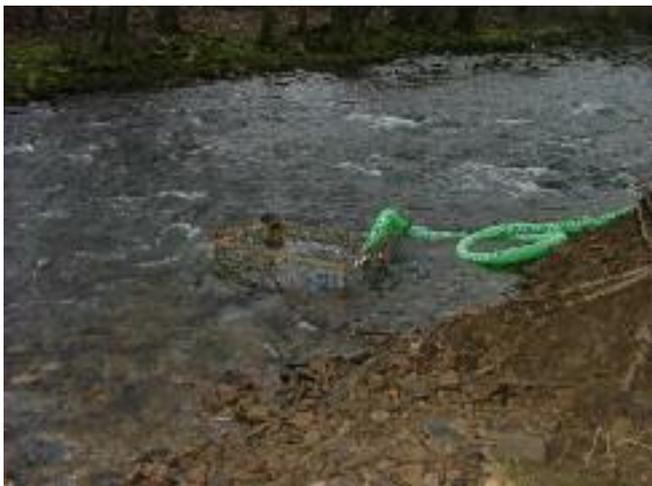
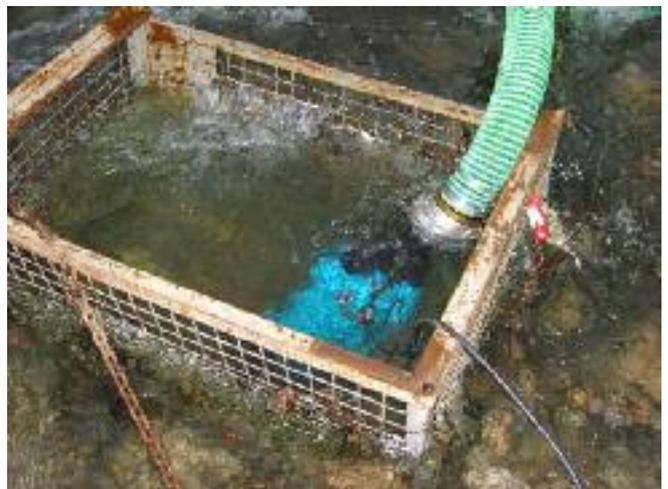
Cooling water supply, Germany

For an emergency cooling water supply, water had to be taken from a drainage ditch.

A pump in the KTZ series was used, secured with a steel cage. Particular value was placed on operational safety, which was guaranteed at all times thanks to the quality of our pumps.

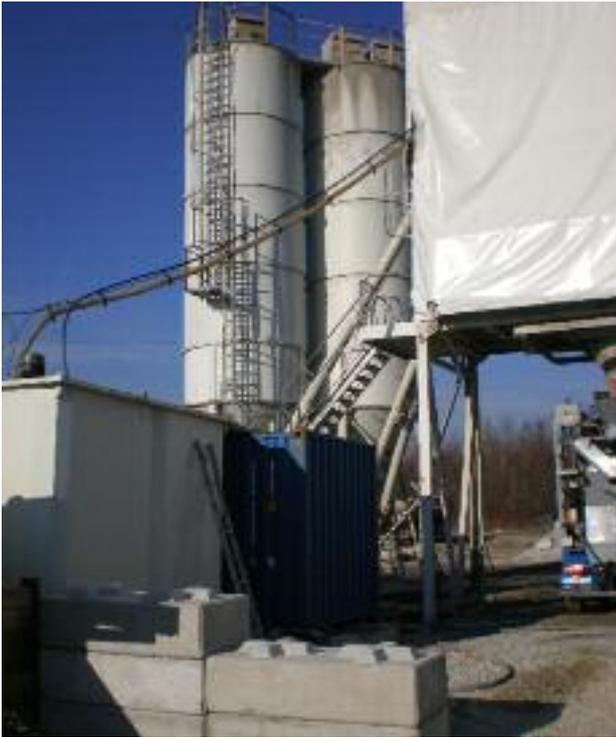
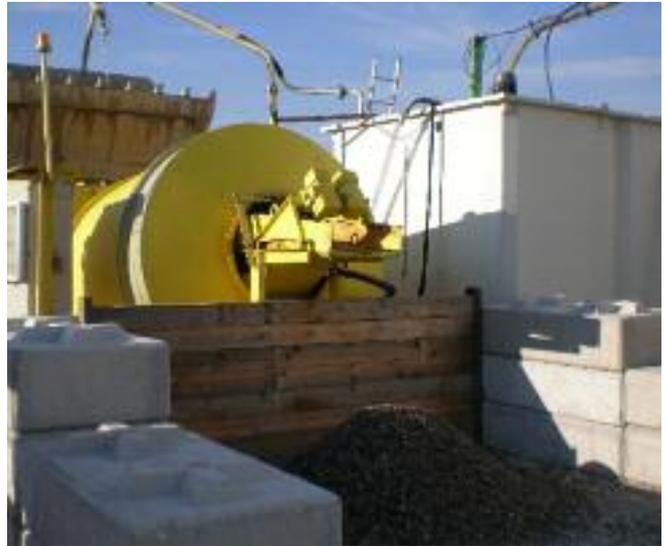
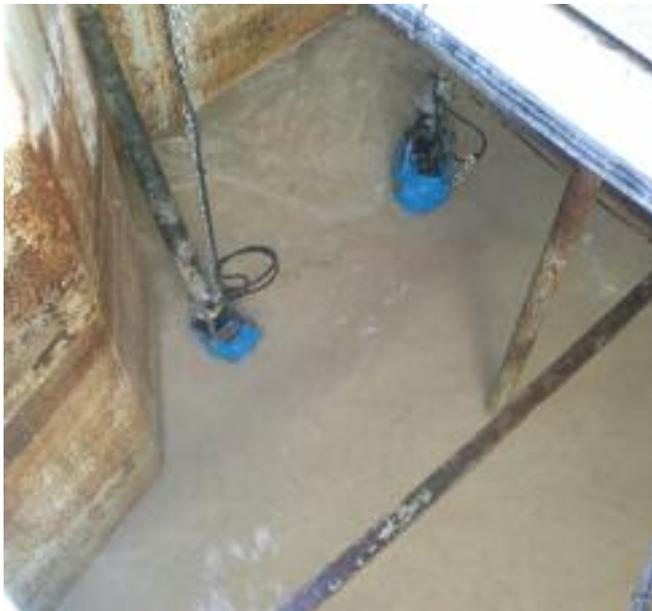
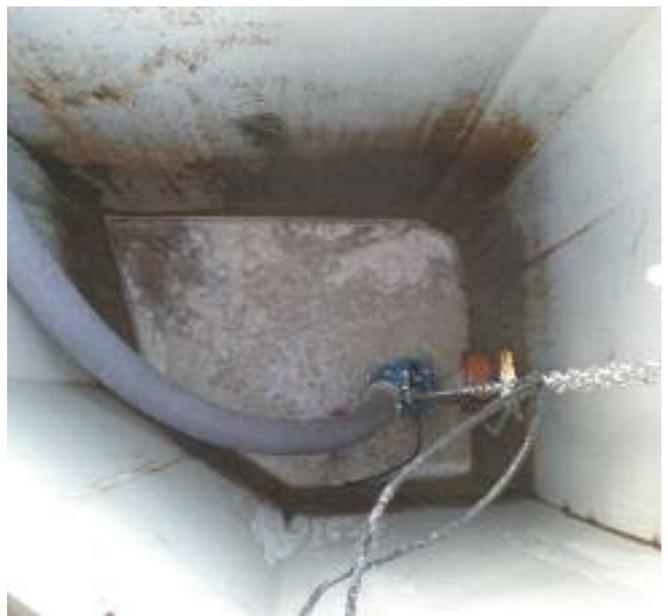
Riebel concrete plant, Freimar, Germany

Pumping of abrasive water in different parts of a recycling plant.

Model KTZ21.5, KTZ22.2, KTZ33.7, and KTZ43.7 pumps were installed:

- for pumping into the scales
- as a boom pump for washing vehicles
- for overflow
- in the runoff basin

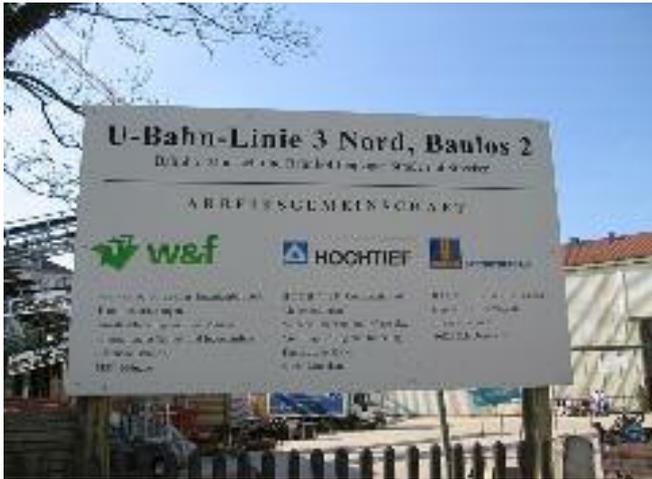
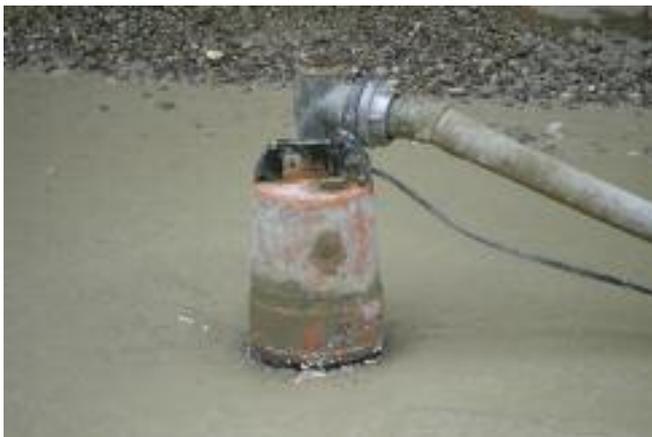
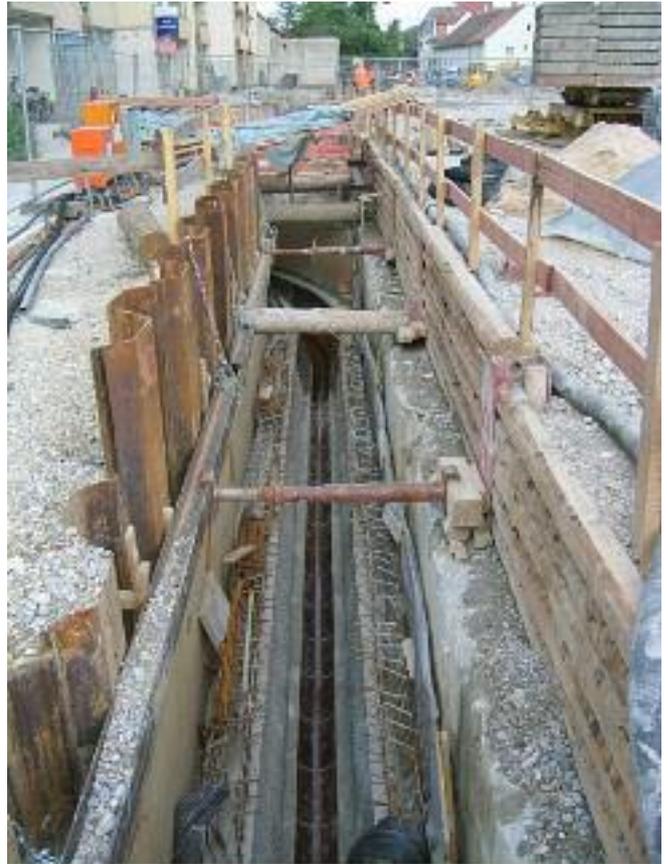
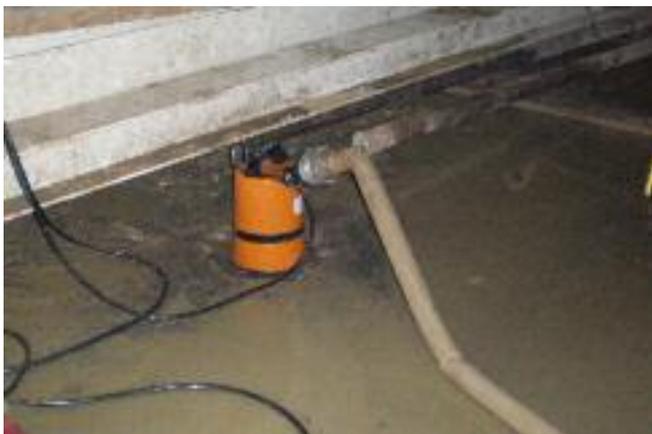
Moosach subway tunnel, Munich, Germany

Groundwater drainage during the entire construction phase: Laying of sewers, construction of subway tunnels and stations.

Multiple submersible pumps from the LSC series (puddle sucker) were used.

The special characteristics of Tsurumi pumps, such as an internal mechanical seal, upstream shaft sleeve with gasket and a patented oil lifter allow them to be used in snore mode over an extended period.

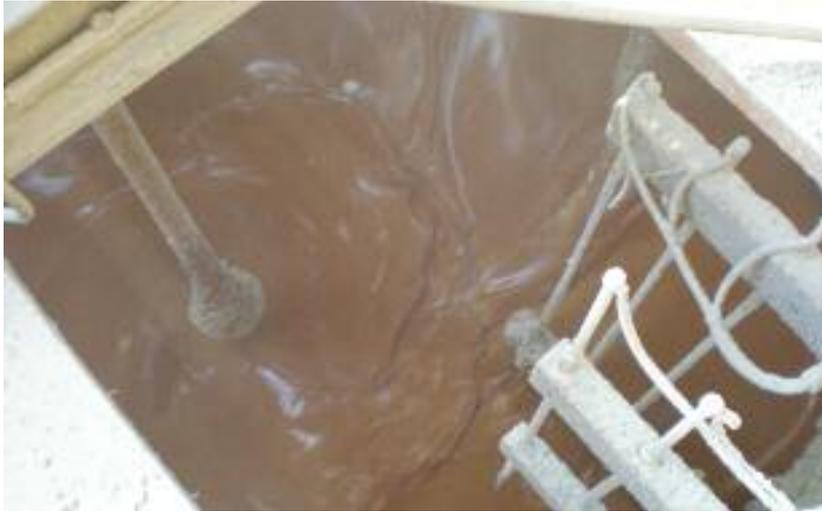
Rupp gravel plant, Dillingen, Germany

The condensed slurry from the clarification tower is pumped into the buffer silos of the chamber filter press. The consistency of the medium ranges from fluid to a thickly flowing mud. Lime is added to the mud for conditioning.

The high proportion of abrasive sediments could not be pumped satisfactorily using the pumps in use until now. The result was a high degree of wear and replacement part costs.

Use of a GPN3-100 with an agitator in long-term use. Thanks to its quality features, this model can be used and operated long-term with a high proportion of sediment. This is ensured using high-quality ball bearings and double inside mechanical seals made of silicon carbide and additional shaft protection sleeves.

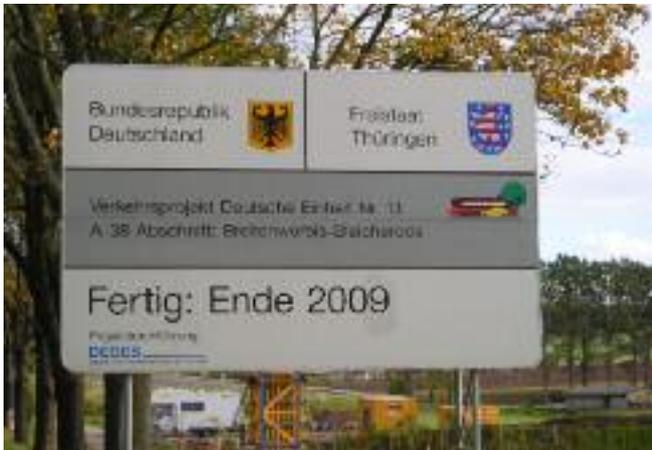
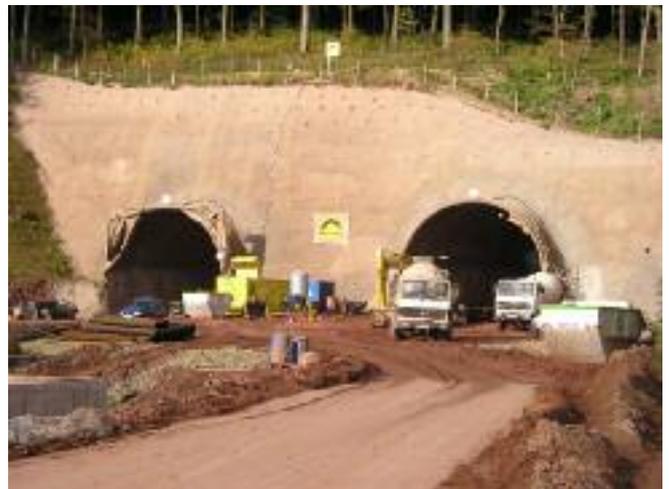
Höllberg A38 tunnel, Thüringen, Germany

Drainage via open dewatering during tunnelling operations.

Multiple submersible pumps from the KTV and KTZ series were used. The special characteristics of Tsurumi pumps, such as an inside mechanical seal, shaft sleeve with oil ring and a patented oil lifter allow them to be used in 24-hour suction operation.

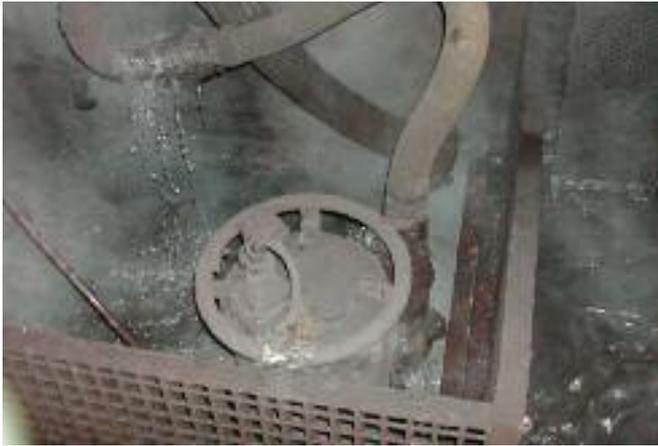
Badische Stahlwerke GmbH, Kehl, Germany

Pumping of abrasive and cinder-loaded water. Water carrying cinders must be conveyed to a height of about 4 m, where it is reintroduced to the water circulation. The water is cooling water for the rolling process, which runs off into the shearing trench

over different paths. In the trench, there is a gravel curb to catch fragments from a shaping shear.

Two model GPN3-80 pumps were provided, with one pump on standby. The pump in use is operated around the clock, seven days a week, without visible wear.

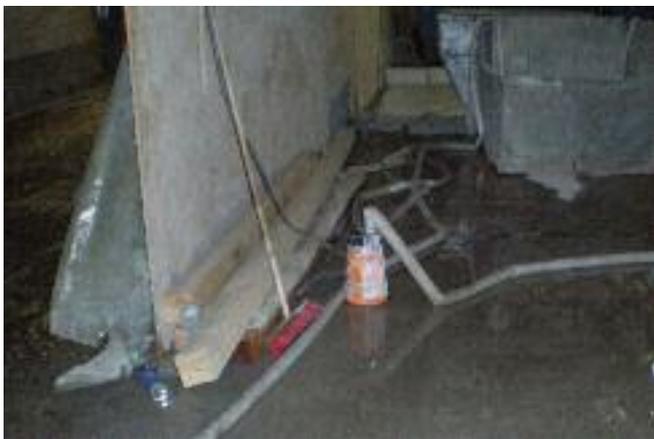
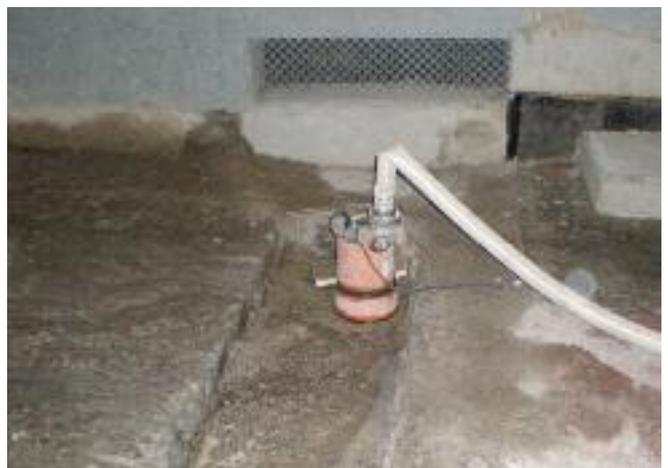
Renovation of underground parking garage, Munich, Germany

Renovation of an area of 4000m², construction time 12 months. Removal of concrete surface with high-pressure equipment at up to 3000 bar water pressure. Draining water jets (up to 240 liters/min) with a high mud load must be pumped away.

The incoming muddy water is pumped out with a total of ten model LCS1.4S pumps. These are abrasion-resistant residual water pumps, which pump out the water down to a height of 1mm. The built-in check valve allows continuous suction operation; no personnel is needed to monitor the pump operation.

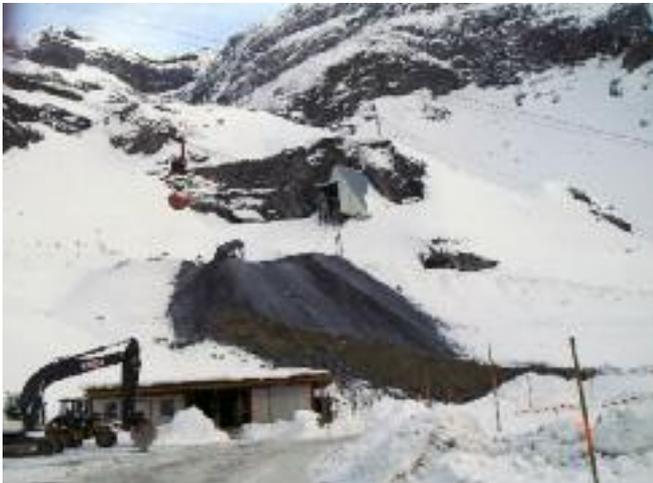
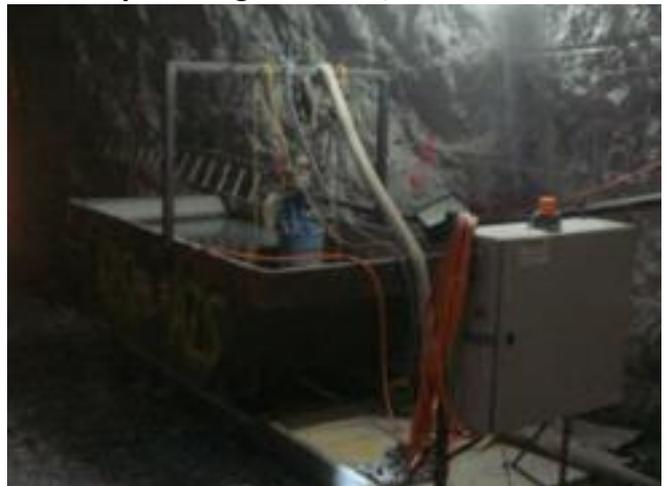
AZS ARGE Zugangsstollen, Linthal, Switzerland

Shafts with a pronounced tilt, drilling water and incoming water must be pumped out.

LH322W submersible pump is used, with a second pump held in reserve. The pump is frequency-controlled and regulated using a submersible pressure probe. If the water level rises, the speed is increased; when the water level falls, the speed is reduced. This type of control was chosen so that a very small pump container can be used which can be easily replaced after each new tunnel section. A model KTZ47.5 pump is built into the drainage water treatment.

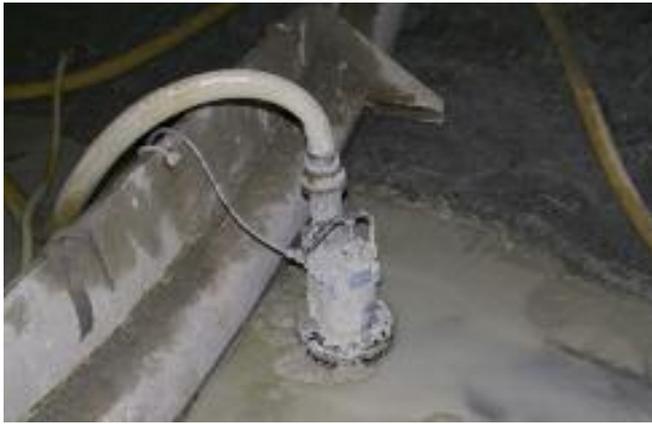
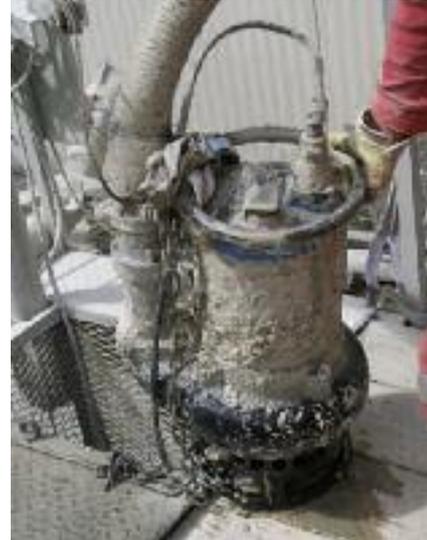
NEAT Amsteg and Erstfeld construction sites, Switzerland

Incoming contaminated drainage water from the tunnels are guided to the collection basin of the sand press. This was initially done with standard commercial construction pumps, but the impellers were worn out after a very short time.

Four GPN3-80 Tsurumi mud pumps with agitator were used. This 4-pole jacket-cooled pump is designed for use in the harshest of mud environments, so that the impeller, agitators, and suction plates are fabricated of custom-coated chromium cast iron with a Brinell hardness of 415 to 425. After 6 months of use, almost no wear could be detected.

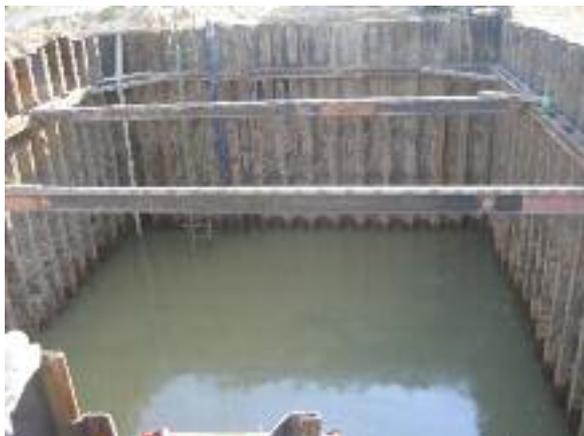
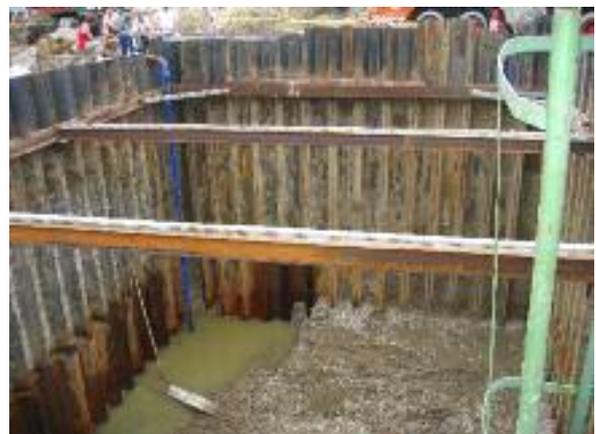
Zagreb Arena, Croatia

Large amounts of groundwater and rainwater had to be pumped out of the foundation during construction.

Installation of a model KRS1022 pump. This pump is particularly well-suited for the pumping of larger amounts of water over a relatively low height. Due to the crowded conditions, the pump was protected using a specially fabricated cage.

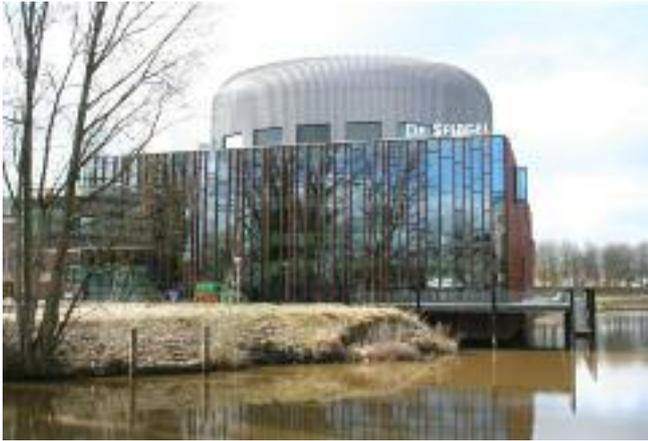
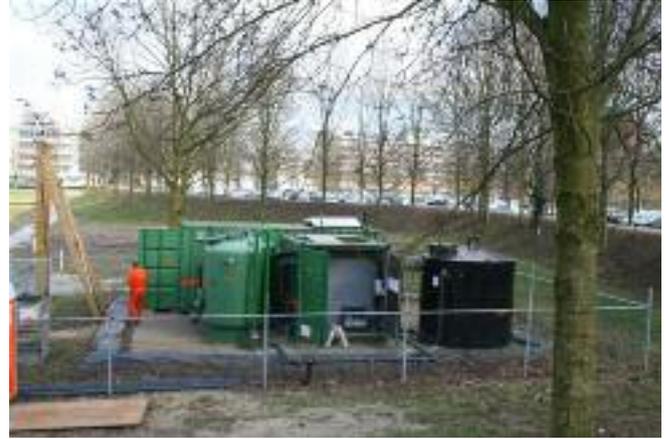
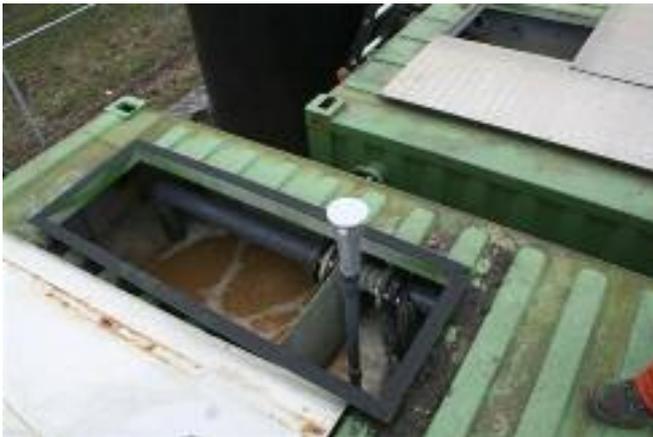
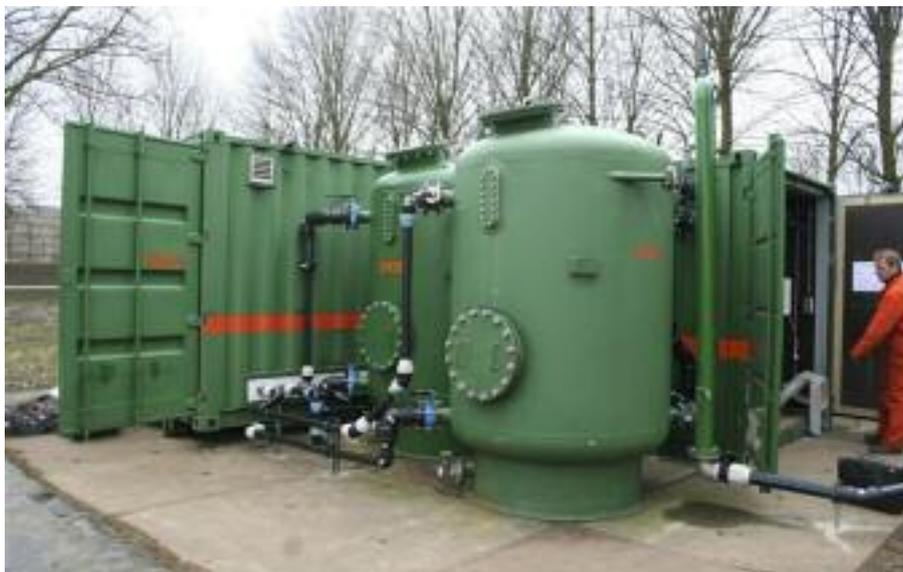
Iron deposition, Zwolle, Holland

The groundwater is highly impure with dissolved iron. Clarification using oxidation and filtration of iron oxide using a water softener system. Then filtration through a sand filter and finally an activated carbon element.

Oxidation carried out by installing a Tsurumi model 32TRN21.5 submersible aerator. The use of a submersible aerator already causes the greater part of the iron to oxidize and precipitate, so that it remains in the sand filter. The rest of the system is less contaminated, requiring fewer replacement of the expensive carbon filter. The result is that maintenance and operating costs are minimized.

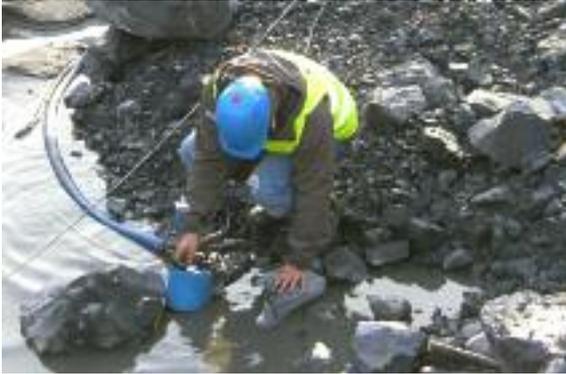
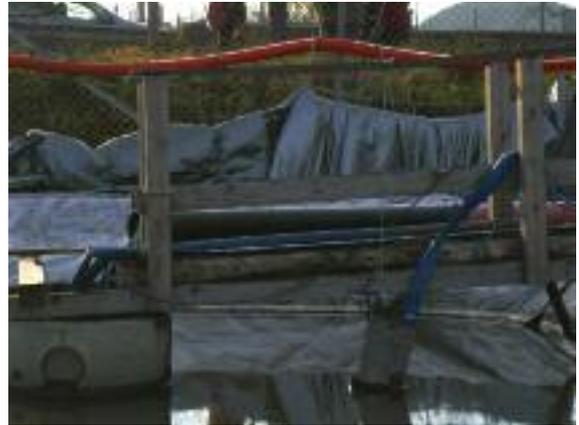
Construction of a shopping centre in Oslo, Norway

During bulldozer excavation of larger areas at below-freezing temperatures, water needed to be pumped out from many points. At the same time, nine shipwrecks from the 17th century were found. Archaeologists from the Norwegian Maritime Museum had to keep the sites dry.

Model LB-480A and KTVE21.5 pumps were distributed over the whole construction site. These pumps are equipped with a sensor that turns the pump on and off as the water level changes. This saves power and avoids unnecessary wear. Thanks to their robust constructions, the pumps can also withstand a great deal of cold.

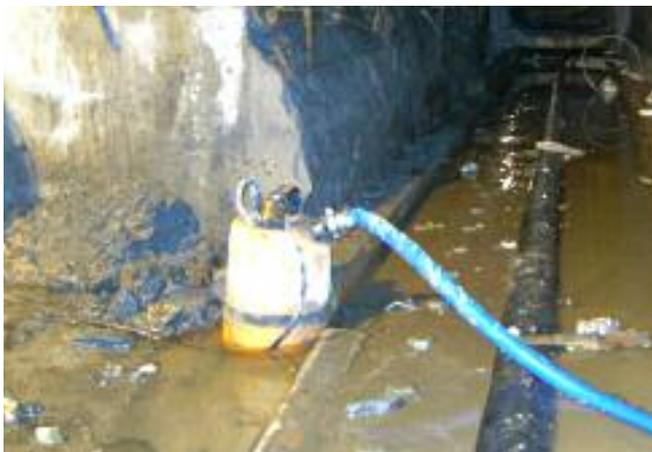
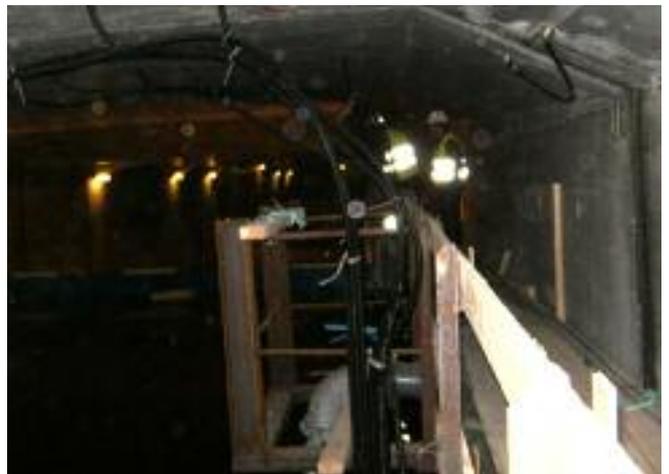
Caisson tunnel, Oslo, Norway

During construction of a tunnel with caissons, the individual elements had to be emptied after positioning. In addition, water flowing in along the segment had to be pumped out.

To pump larger quantities of water, pumps from the KTV series were used. Along the segment, model LSC pumps were installed. These flat suction pumps remove water above a residual level of 1mm, allowing work to proceed in as dry an environment as possible.

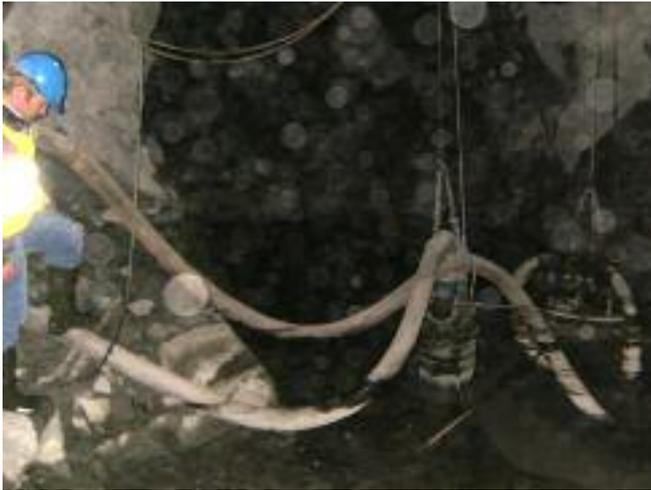
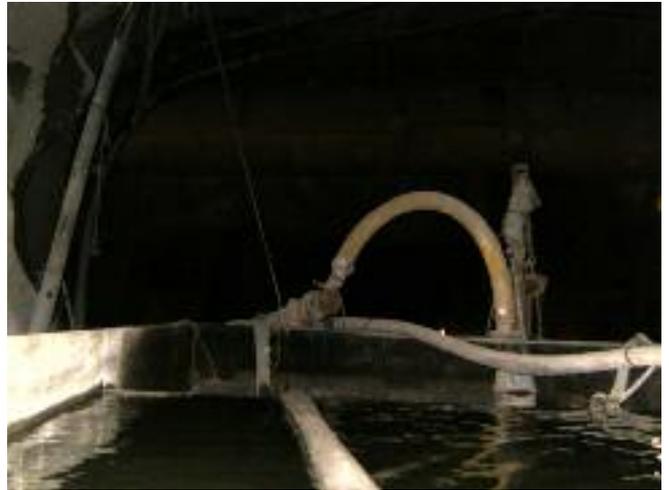
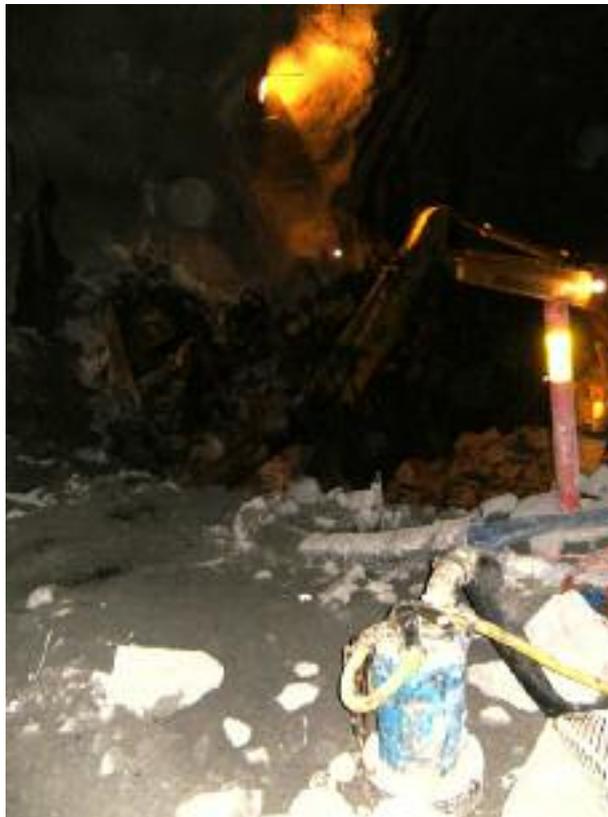
Vinterbro Tunnel, Norway

With a falling road grade in the tunnel, the water runoff from the mountain had to be pumped upwards over longer distances.

Use of multiple module KTV and LH pumps. Particularly the LH series provides the conveyor pressure needed to overcome the distances between the intermediate basins.
